TANK 4 AND LEACHATE TRANSMISSION SYSTEM REPORT

CONSTRUCTION QUALITY ASSURANCE (CQA)

ERDF CONSTRUCTION CELLS 9-10

## CQA PHOTOGRAPH LOG WEEK 35 (10/4/10 TO 10/9/10)

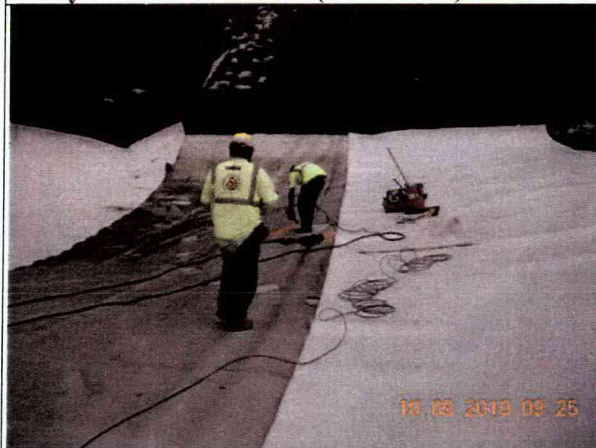
Facing N – ESI completing repairs to the primary geomembrane in the Cell 10 sump prior to installing the 100-mil rub sheet.

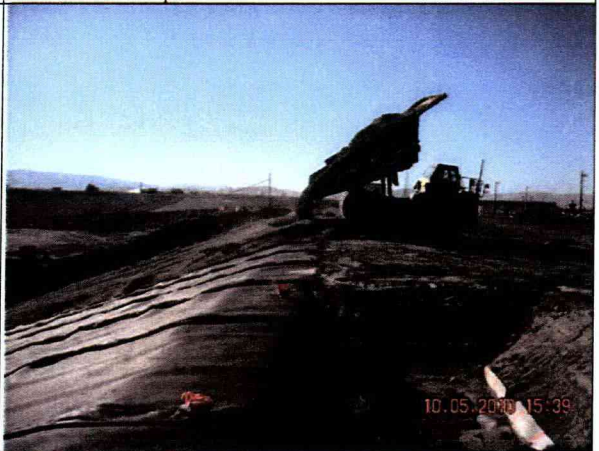
Facing S – TWS beginning to place operations at the top of the north slope of Cell 9. (Placement was subsequently halted by WCH)

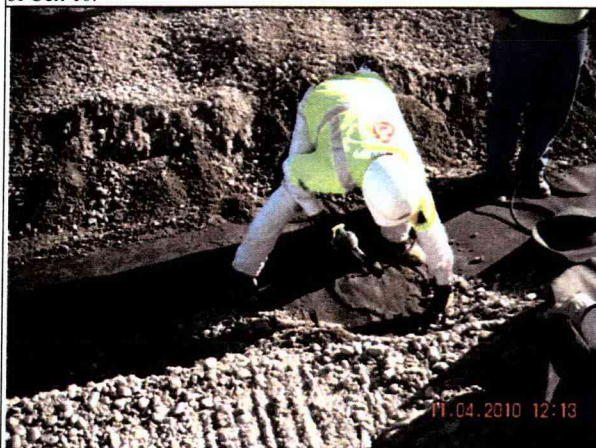
Facing Down – ESI is repairing the 16-oz fabric on the floor of Cell 10. TWS snagged the fabric while excavating for the collector pipe.

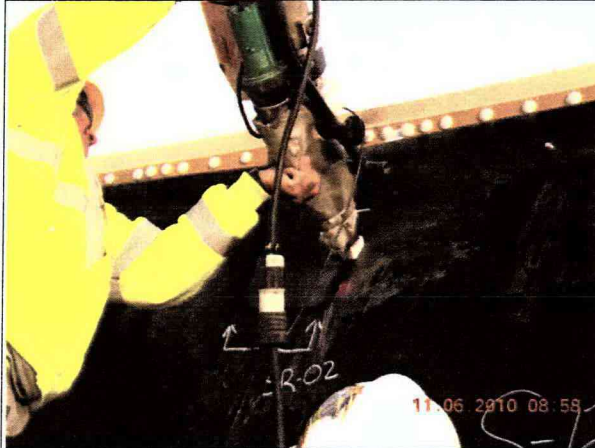
Tank 3 – ESI making secondary repairs on the wall of Tank 3.

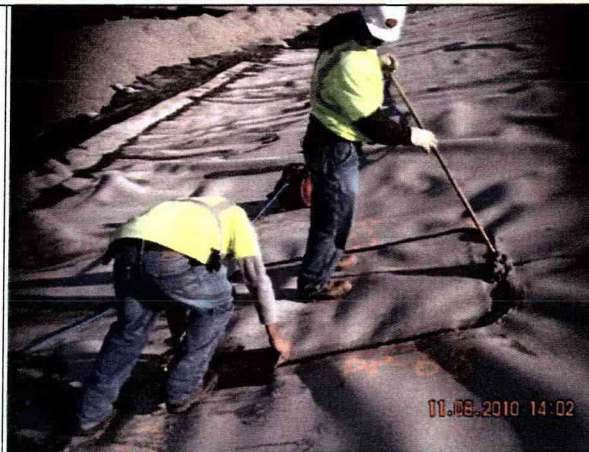
Facing Down – ESI performing vacuum tests on primary repairs on the south slope of Cell 10.

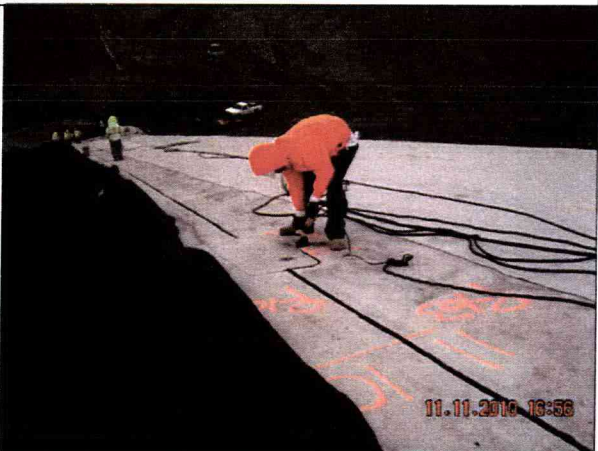
Facing N – ESI making repairs on the south slope of Cell 10.

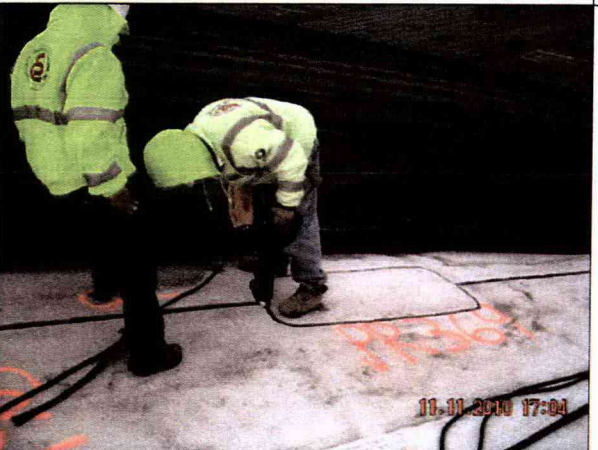
Facing NW – ESI making repairs on the south slope of Cell 10.

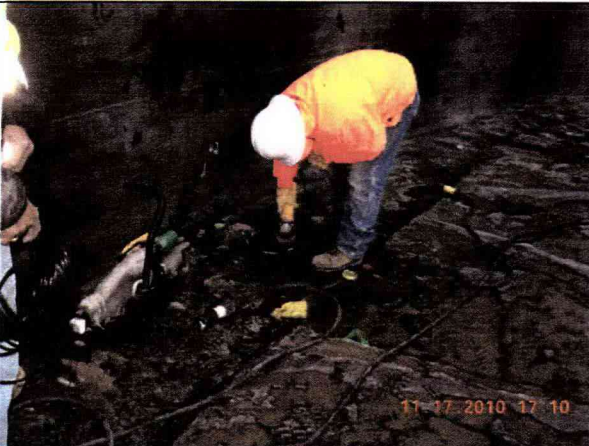
Tank 4 – ESI making secondary repairs to leaks found during the electronic leak survey.

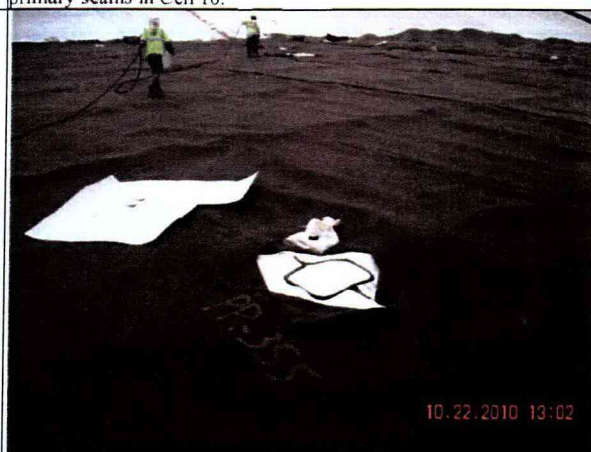
Facing Down – Due to failing destructive testing ESI located and repaired extrusion welds that had been covered by 16-oz fabric.

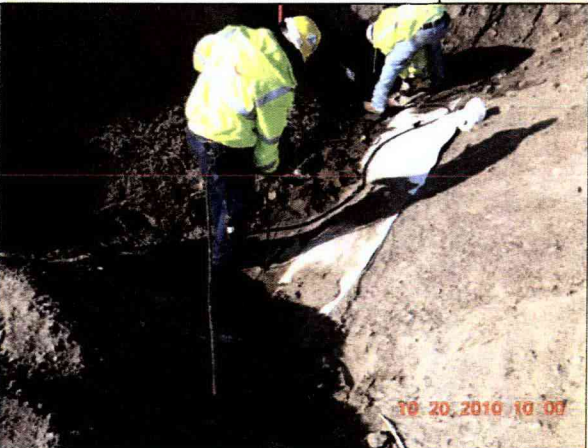
Facing W – ESI completing the welding of the air-release holes in the north anchor trench.

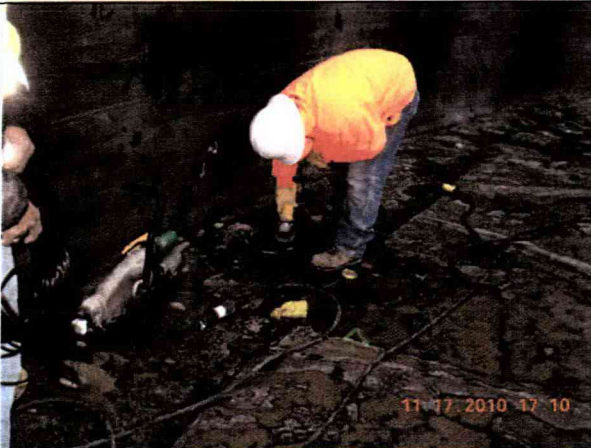
Tank 4 – ESI making secondary repairs to leaks found during the electronic leak survey.

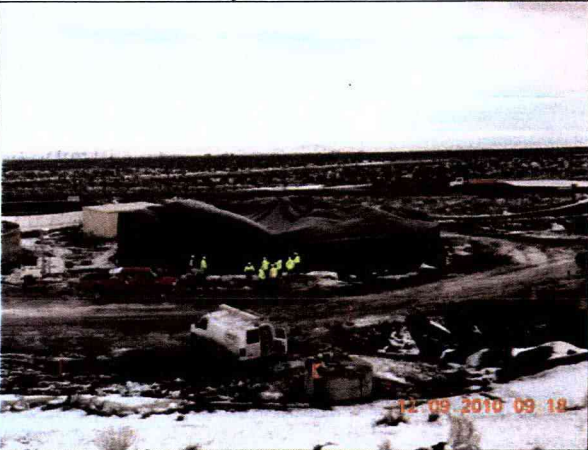
Facing N – High winds began to cause damage to the tent over Tank #3. The tarp was subsequently removed.

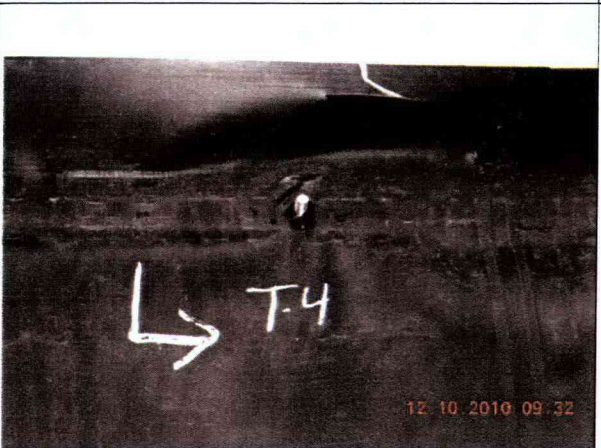
Tank #4 – Bolt tears in the secondary liner on the north side of Tank #4. ESI repaired all bolt tears and more baton strip bolts were installed.

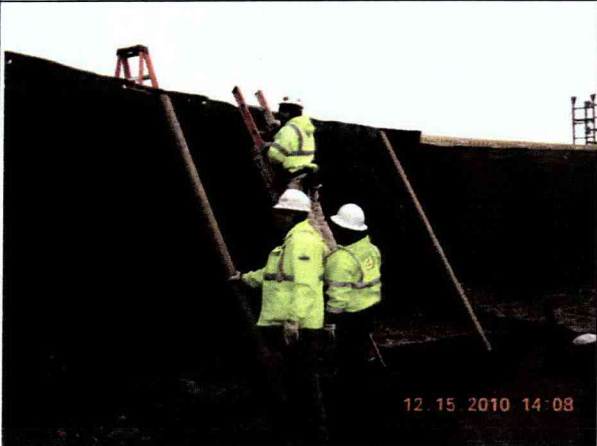
Facing E – ESI using 2x4 wood beams to brace the geomembrane as it is pulled up the wall of the tank. After the geomembrane was pulled up past the anchor bolt tears, ESI replaced the anchor bolts.

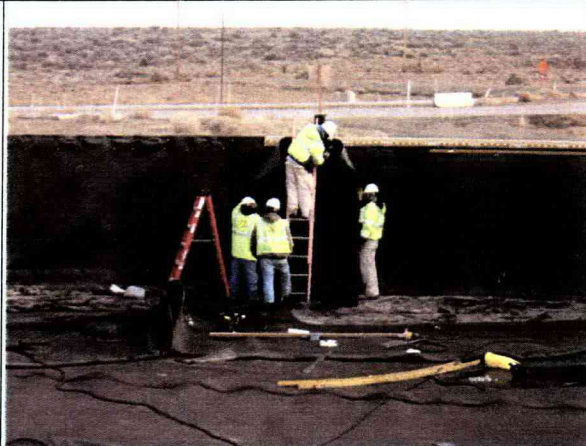
Facing N – ESI placing new panel S-17 in the Tank 3 secondary geomembrane in order to remove the trampoline in the tank wall.

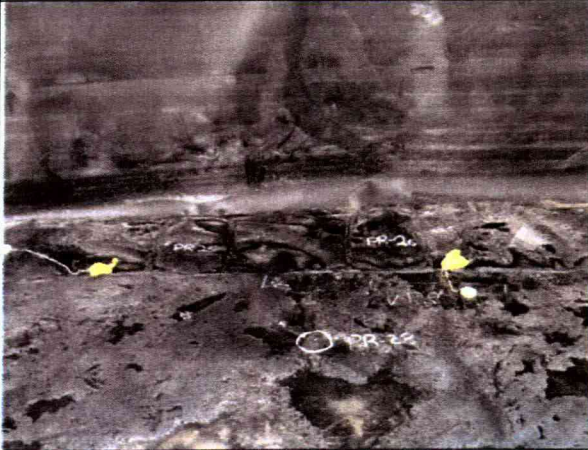
Facing down - Leak location markers left by LLS on the primary in Tank 4.
